**STOP THE ROT:
TAKING ACTION TO ENSURE BOREHOLE
AND HANDPUMP QUALITY**

Steve Kumwenda, (Hydrogeologist) Baseflow Malawi
Side Event on Groundwater for Rural Water Supply
@ UN Water Groundwater Summit 2022
Paris - 6th December 2022

BASEFLOW'S BOREHOLE FORENSICS FINDINGS

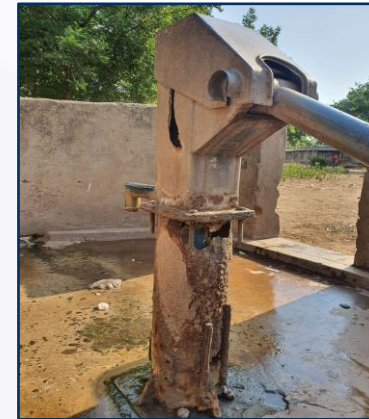
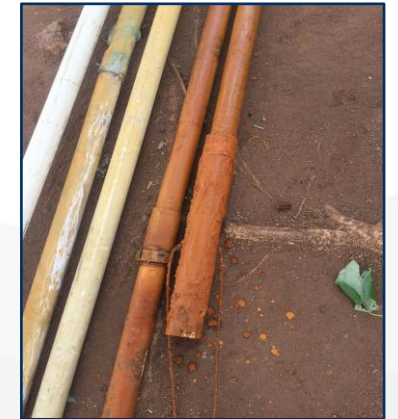
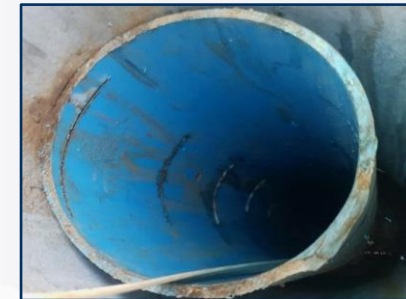
- Unsuitable well designs and poor construction e.g.
 - Manually cut casings,
 - Inadequate borehole verticality (straightness)
 - Inadequate borehole depth
 - Yielding insufficient
 - Poor sitting (lack of hydrogeological understanding)
- Corrosion of Afridev Pump galvanized iron components in areas with high Electrical Conductivity (i.e. high salinity)

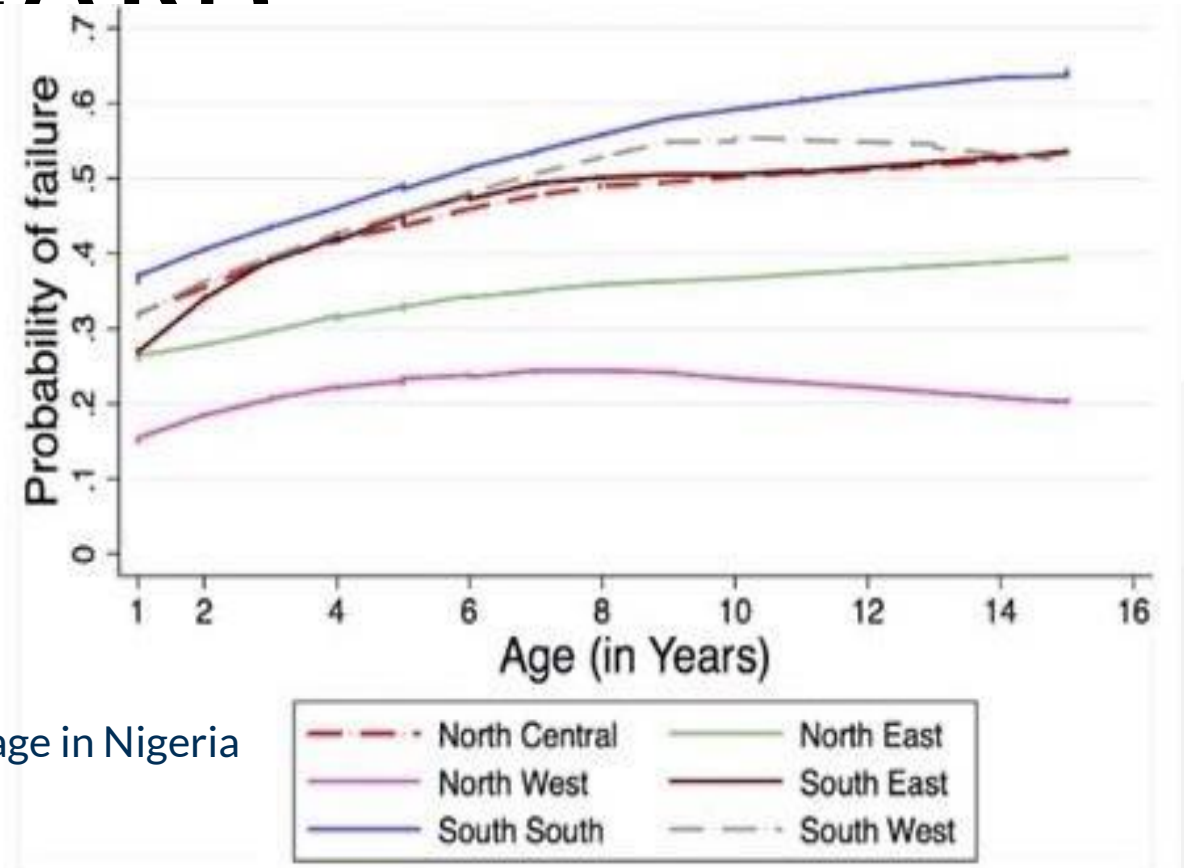
Figure: Probability of water point failure by age in Nigeria
(Source: Andres *et al*, 2018b)

- 15% to 30% of water points failed in the first one to two years in Liberia, Sierra Leone, Malawi and Tanzania (Tincani *et al*, 2015).
- 15-30% of water points* in Nigeria were likely to fail in the first year (Andres *et al* (2018b)).

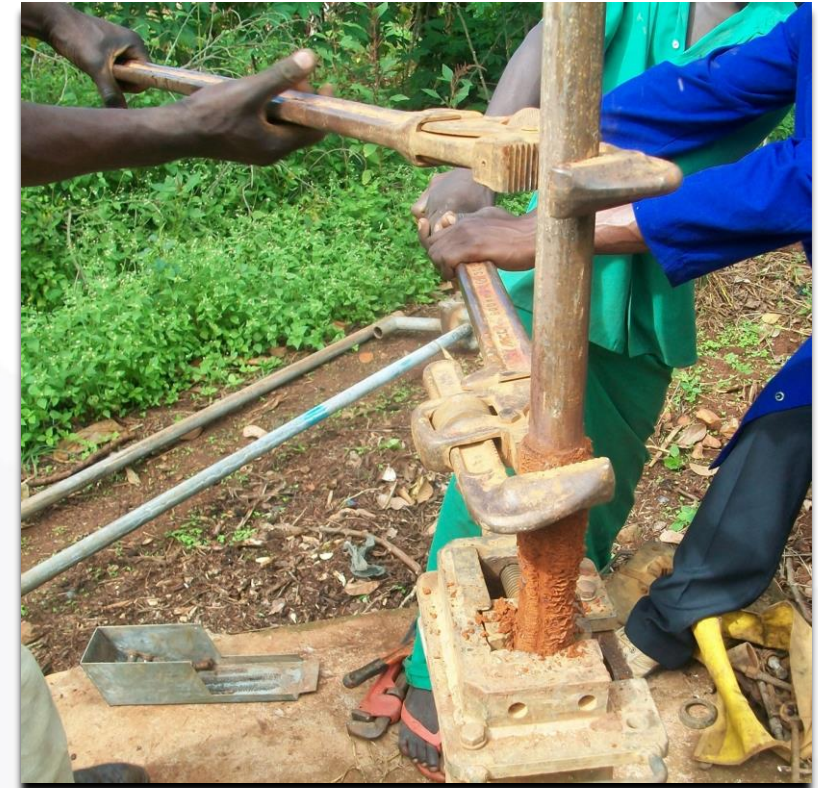
Figure: Removal of corroding riser pipe in Hoima, Uganda in 2012 (Source: Larry Bentley).
Note: In 2018 the Government of Uganda issued a directive to prevent further use of Galvanised Iron riser pipes throughout the country

- In the 1980s/early 1990s it was concluded that:
 - i. total iron concentration in natural groundwater is **rarely greater than 1 mg/l**
 - ii. the red water (iron) problem in handpump-equipped wells is usually caused by corrosion
 - iii. galvanisation does not protect rising mains and pump rods from corrosion if $\text{pH} < 6.5$ (or if salinity is high)

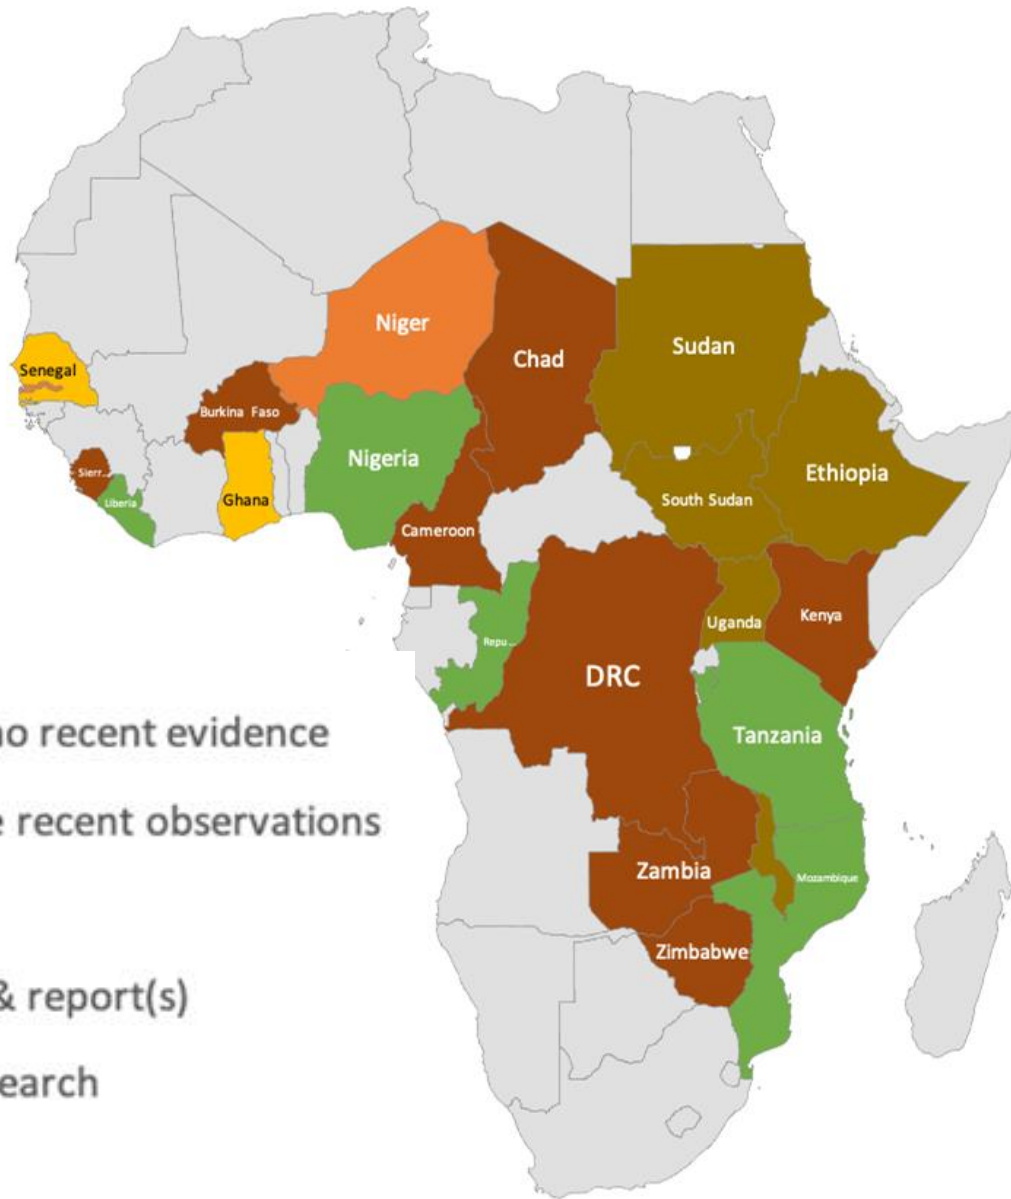
COUNTRIES WITH EVIDENCE OF RAPID HANDPUMP CORROSION (DANERT, 2022B)

- Old report(s) only - no recent evidence
- Old report(s) & some recent observations
- Recent observation
- Recent observation & report(s)
- Recent academic research

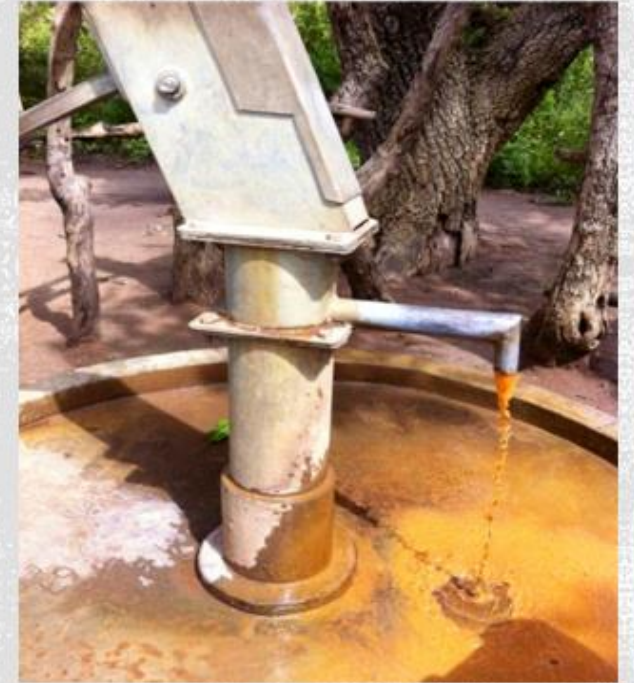
Red, iron-rich water being pumped
Photo: WaterAid Uganda

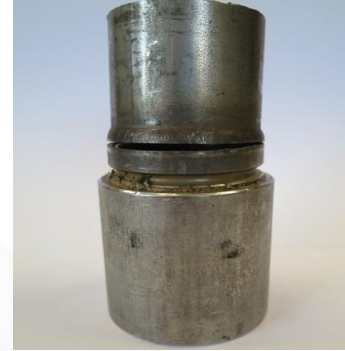
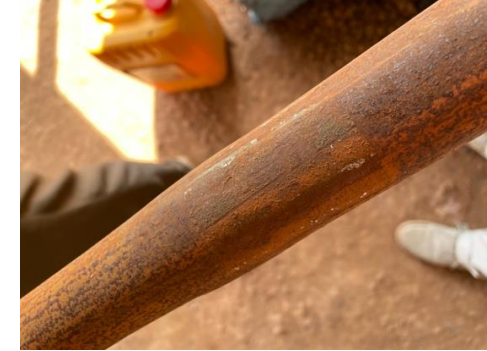
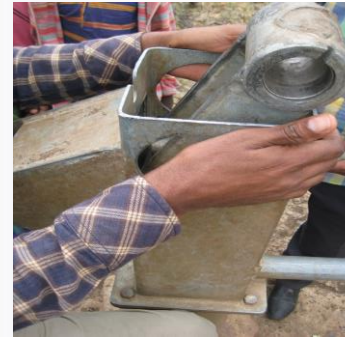
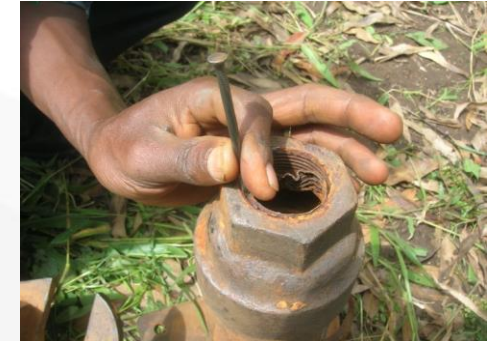
- Specific concerns over quality have been observed and/or measured in many handpump components in several countries* such as:
 - Components too light
 - Non-standard material composition
 - Thin galvanising
 - Non-conformant dimensions
 - Defective materials
 - Non genuine parts
 - Lack of durability (especially seals)

Figures: Select quality problem (Photos; Larry Bentley, Tony Beers and Richard Carter (Danert, 2022c))

These can lead to premature failure of the handpump.
